# Service Bulletin

**Subject:** Repeated Radio/display Resets, Volume Control Inoperative, Waiting for Update Media Message, Voice Command For Calling Bluetooth Phone Contacts Inoperative, Service Rear Vision System Message, Radio Turns On Unwanted At Startup, and/or Navigation Radio Destination State Defaults To WV

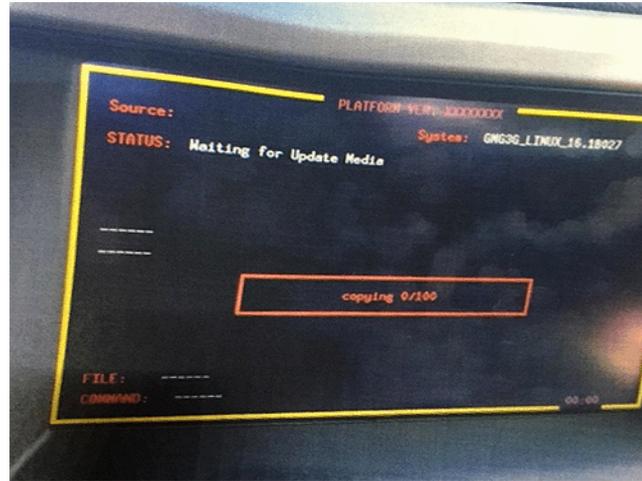
- Random Infotainment system display resets while driving, screen temporarily goes blank and then returns after approximately 5 seconds.
- The “waiting for update media” screen appears/appeared while driving and may disappear after 80 minutes.
- The volume knob or slider bar (Cadillac) will not function.
- Momentary black screen at start up.
- Voice recognition inoperative for Calling Bluetooth Phone Contacts.
- The HVAC controls function but will not show on the main display.
- Seek buttons on the front controls will not function.
- XM only shows radio ID. Station List is blank.
- Radio will shut off and when restarting the vehicle the radio will turn on unwanted.

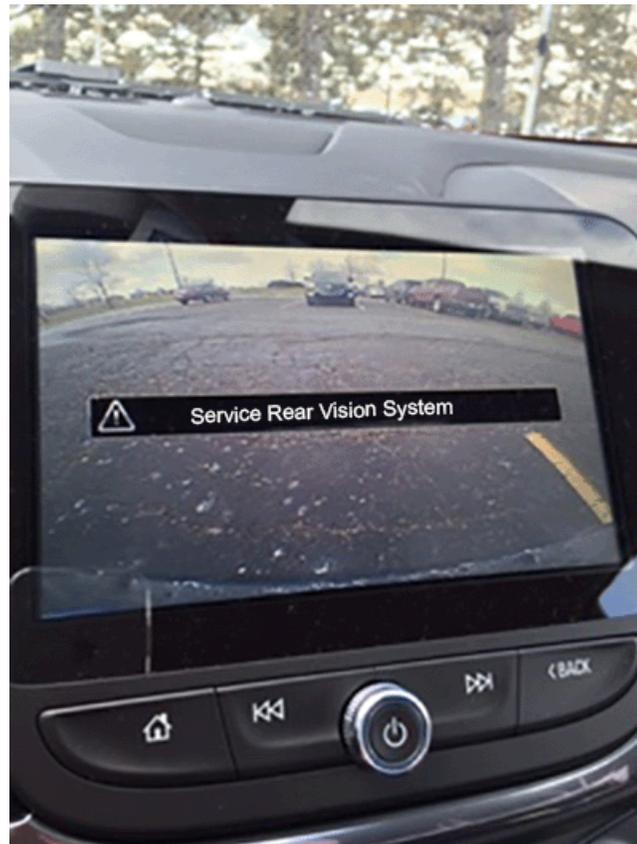
- Service Rear Vision System Message displayed.
- When entering an address using the touch screen the state selection defaults to West Virginia (WV) instead of Virginia (VA).

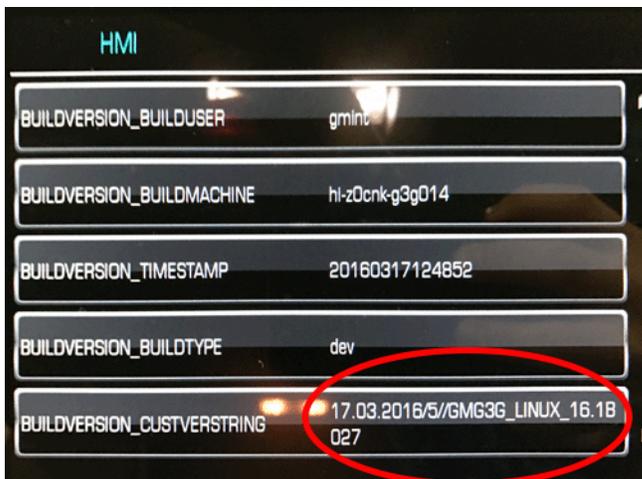
Once in Development Screen press HMI and document the Buildversion-Custverstring

If the software is one of the following, reprogram the Human Machine Interface Control Module. Refer to *Human Machine Interface Control Module Programming and Setup* in SI.

- 2016 Models - 15.1A044
- 2016 Models - 15.1A052
- 2016 Models - 15.2B033
- 2017 Models - 16.1B027
