# Service Bulletin

**Subject:** Repeated Radio/display Resets, Volume Control Inoperative, Waiting for Update Media Message, Voice Command For Calling Bluetooth Phone Contacts Inoperative, Service Rear Vision System Message, Radio Turns On Unwanted At Startup, and/or Navigation Radio Destination State Defaults To WV

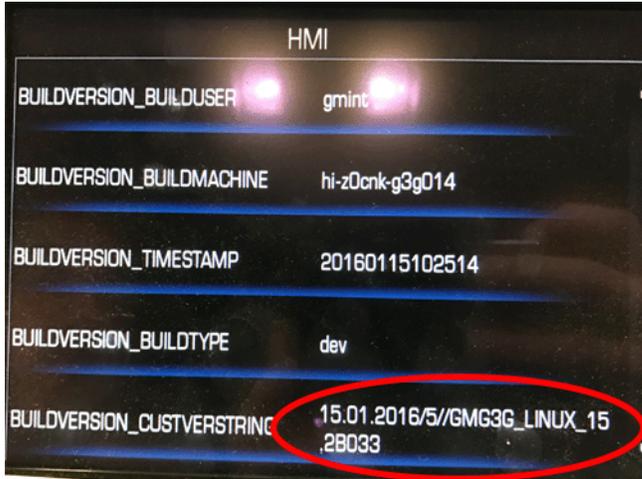
If you encounter a vehicle with the above concern, check the HMI build version.

Verify the HMI build version by completing the following:
